Report to the Legislature
On Enhancing the Reliability of
Florida's Distribution and Transmission Grids
During Extreme Weather
(Update to July 2007 Report)

Submitted to the Governor and Legislature

Florida Public Service Commission
July 2008

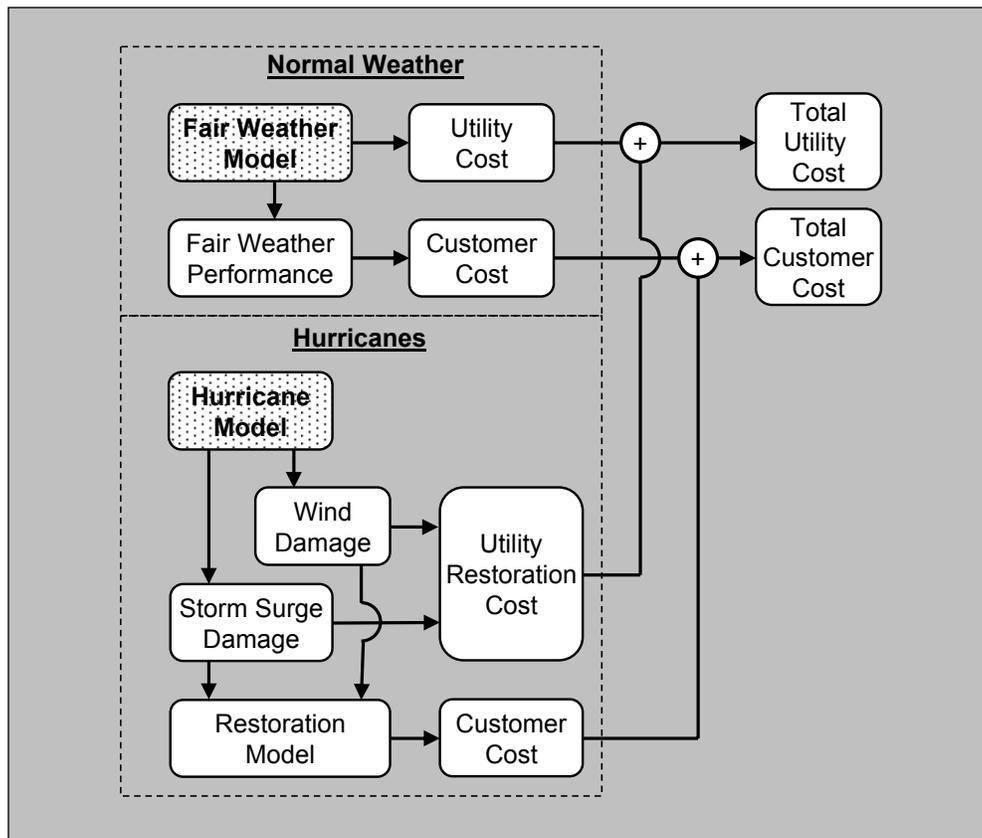
Figure 3. Overview of the Methodology for Analyzing Costs and Benefits

The methodology is separated into two basic components: a normal weather assessment and a hurricane assessment. The normal weather assessment includes the basic cost of utility capital and operational cost information. It also includes high-level reliability information that allows for the calculation of customer interruption information and related costs. A flowchart presenting an overview of the methodology is shown in Figure 3 below.

Source: Quanta Technology

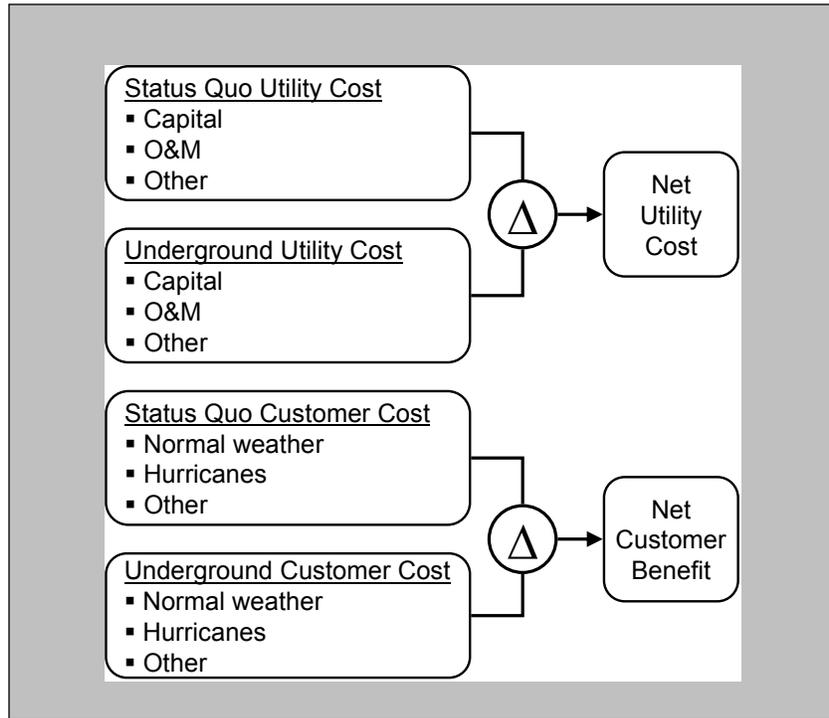
Figure 4: Approach to Costs and Benefits Calculation

The model is designed to compare two scenarios, typically, the status quo scenario and a proposed undergrounding option. Hurricane simulations are performed automatically for both cases so that costs and reliability differences can be compared. This approach is illustrated in Figure 4.

When considering an undergrounding project, a utility will first enter information about the existing system. This data allows the current utility costs, reliability performance, and customer costs to be calculated. The utility also enters information about the undergrounding project, including the initial costs, annual costs, annual savings, and so forth. The assessment is then able to simulate the performance of the underground system and compute associated underground costs, reliability performance, and customer costs. The difference in utility cost between the status quo and proposed scenario is defined as the “net utility cost.” The difference in reliability performance is defined as “net reliability benefit.” Reliability benefit translated into customer cost is defined as the “net customer cost.” Net reliability benefit and net customer cost, taken together, constitute the “net customer benefit.”
